# RESPONSE TO CONTAMINATION FROM FIRE DAMAGED ASBESTOS MATERIALS – A STRUCTURED APPROACH

DAVE COLLINS

## CASE STUDY: WEST PERTH WAREHOUSE

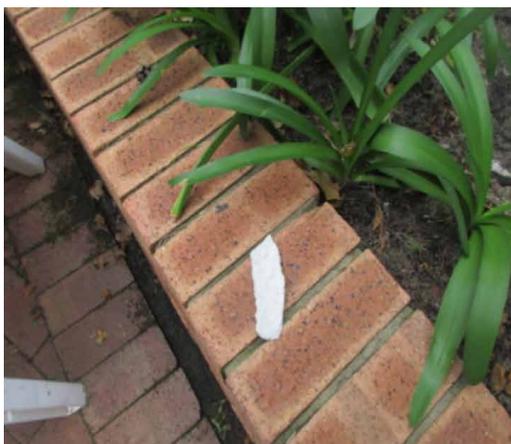
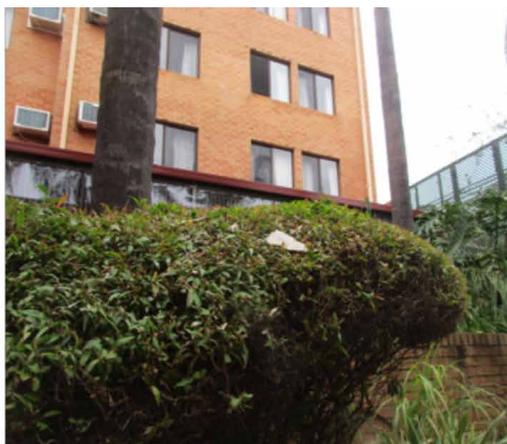
While the tape test showed no asbestos was detected on this outlying area, asbestos fibre cement debris was visibly observed within the laneway, in the children's play area and swimming pool area of a nearby apartment hotel.

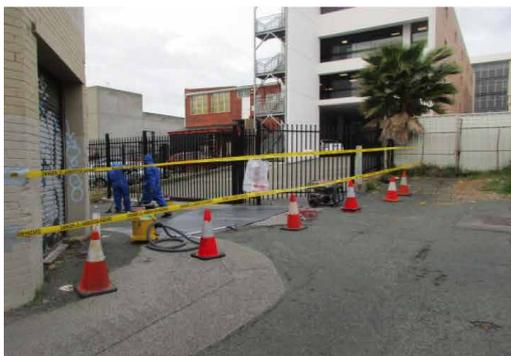
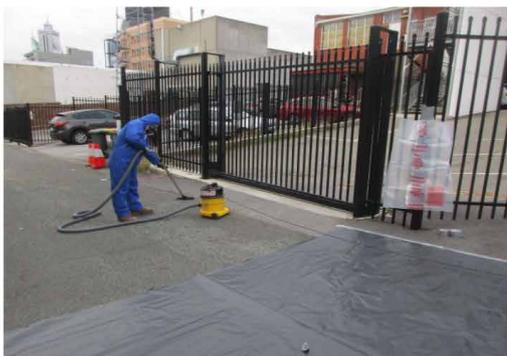
The remediation process starts with the clean-up of all visible debris by a licensed asbestos removalist. This is generally done using an asbestos-rated vacuum cleaner. A 5 metre exclusion zone is established (where possible) to restrict public access during the removal process.

In this case all outdoor furniture within the hotel pool and children's play areas was also wiped down and asbestos fragments within the pool were also physically removed.

We also recommended seeding the pool with a flocculent, running the pool pump and filtering the sand-filter backwash before discharging to the sewer to ensure the pool was safe for use.

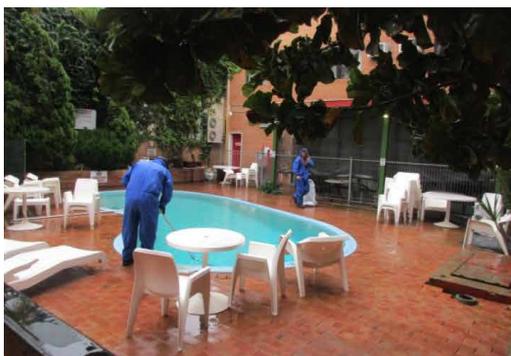
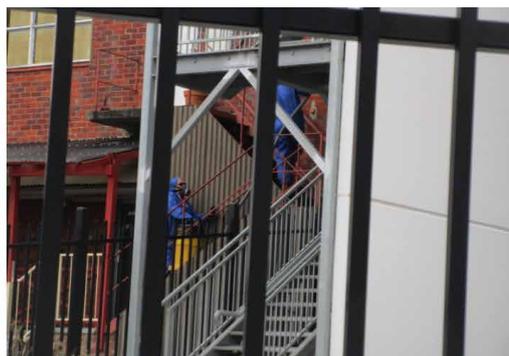
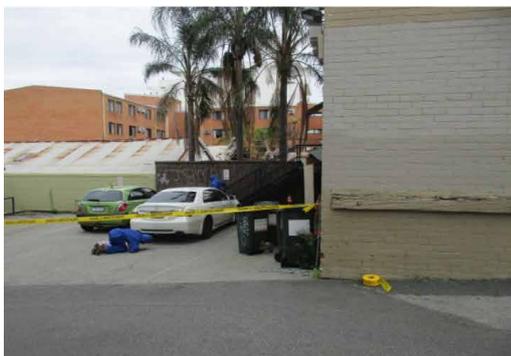
When carrying out the remediation process it is important to employ an asbestos removal contractor with an unrestricted licence. In this case all clean-up works were carried out in accordance with the Code of Practice for the Safe Removal of Asbestos 2nd Edition [NOHSC:2002(2005)].

Finally, to ensure the site was left completely safe we also advised cleaning of all low level roofs within the hotel areas.
