# RESPONSE TO CONTAMINATION FROM FIRE DAMAGED ASBESTOS MATERIALS – A STRUCTURED APPROACH

DAVE COLLINS

## CASE STUDY: WEST PERTH WAREHOUSE

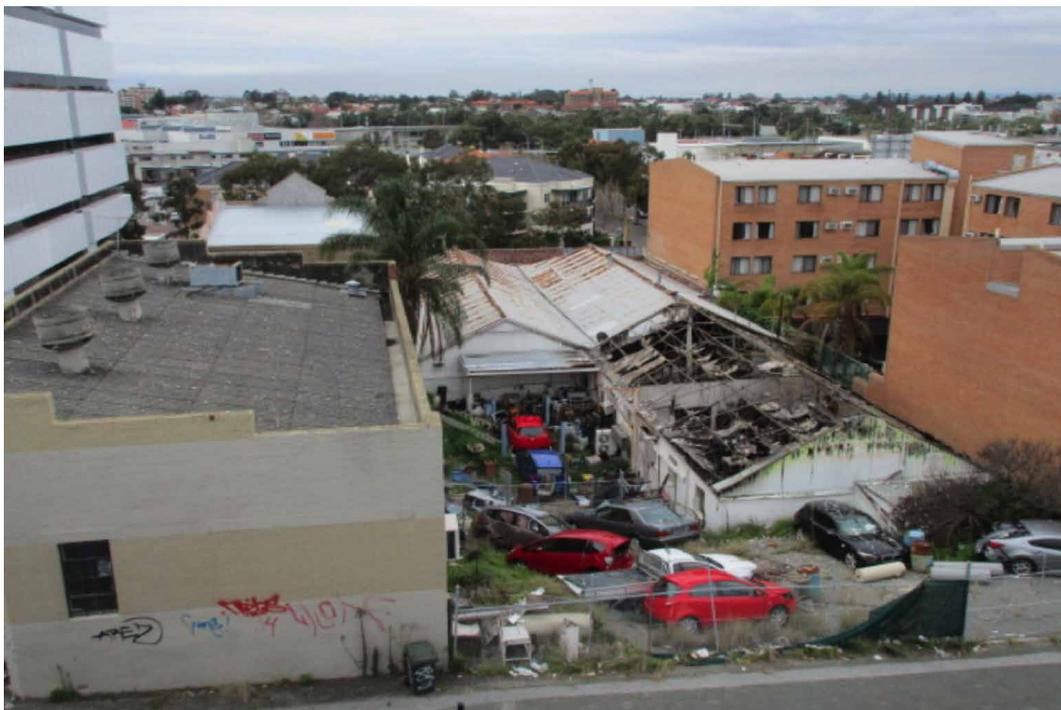
In 2016 a toxic blaze ripped through a warehouse located in the densely populated suburb of West Perth. QED was called in to assist with the assessment and remediation process.
