WATER BORNE PATHOGENS

Pseudomonas aeruginosa.

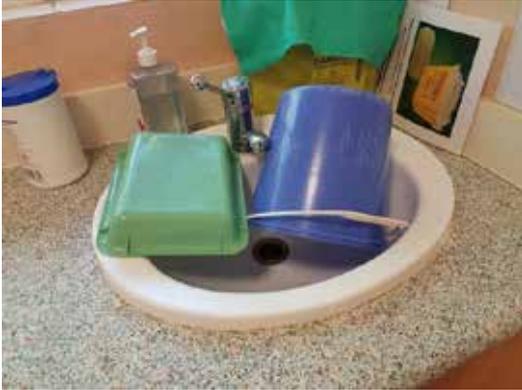
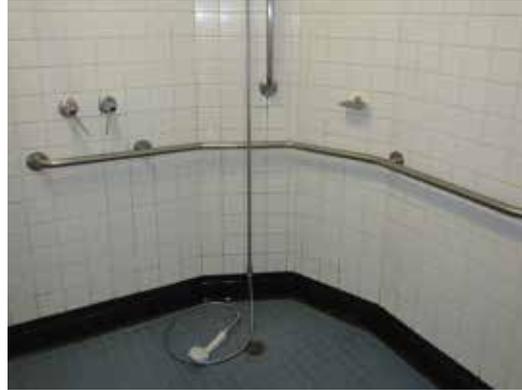
Tapware and wastes are a particular risk for harbouring this organism. Experiments carried out in the UK in response to an outbreak in a neonatal unit showed that the more complex the tapware, the more likely it was to harbour biofilm and *Pseudomonas aeruginosa*.

Sensor tapware, with its' complex internal structure was colonised by biofilm containing *Pseudomonas aeruginosa* much more often than tapware that had simpler internal structures. Consideration should be given to the tapware being chosen for a particular clinical area, as it will need to be cleaned and serviced regularly and may need to be autoclaved to reduce the risks from *Pseudomonas aeruginosa*. Tapware in situ already should be cleaned effectively, and TMVs should always be regularly serviced and descaled.
